Pipeline completed!

25 February 2010

The final chapter

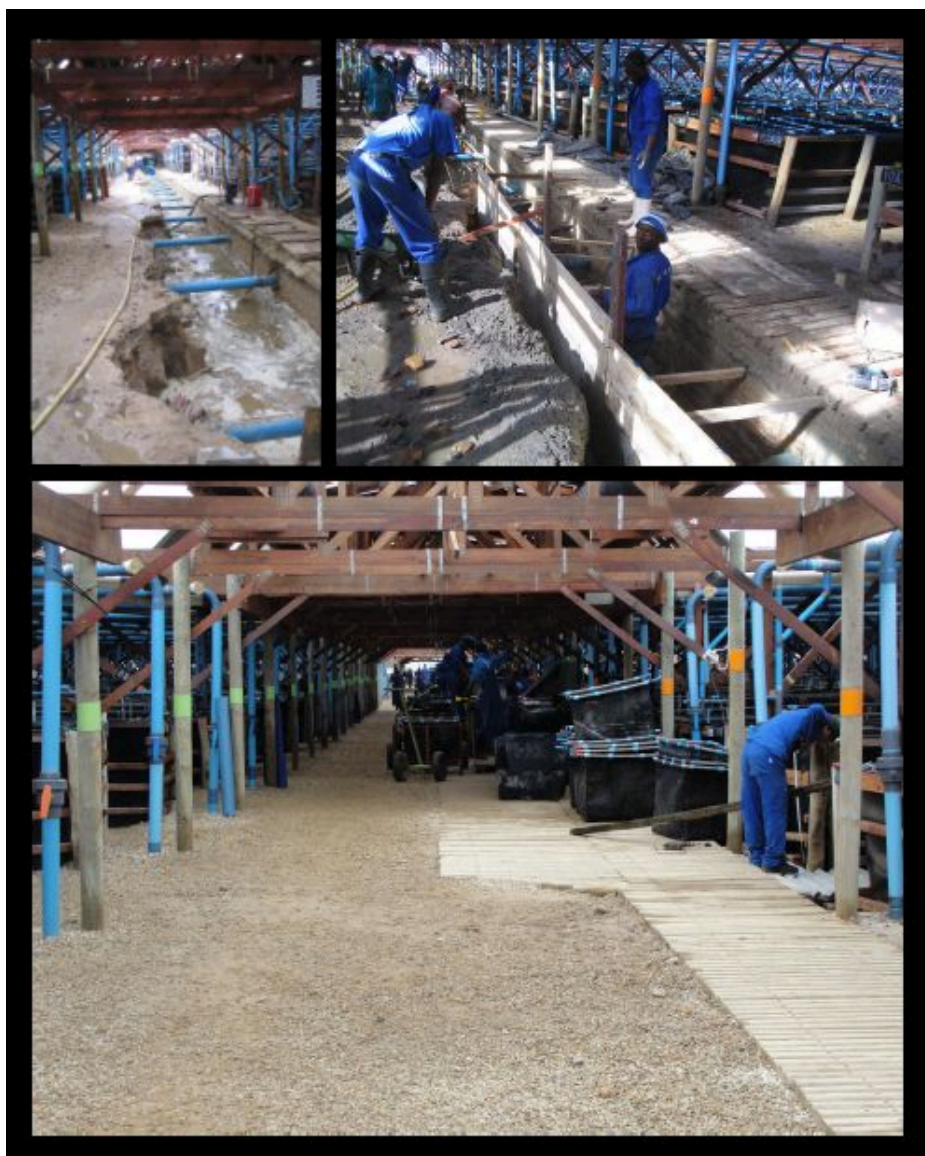
Bergsig channel

Building the additional effluent channel through our Bergsig farm to handle the extra water was a very challenging part of the project. It had to be done around the usual day-to-day farming operations and while returning millions of litres of seawater per hour to the sea. Upon its completion a wooden walkway covering the channel was constructed for safety and accessibility.

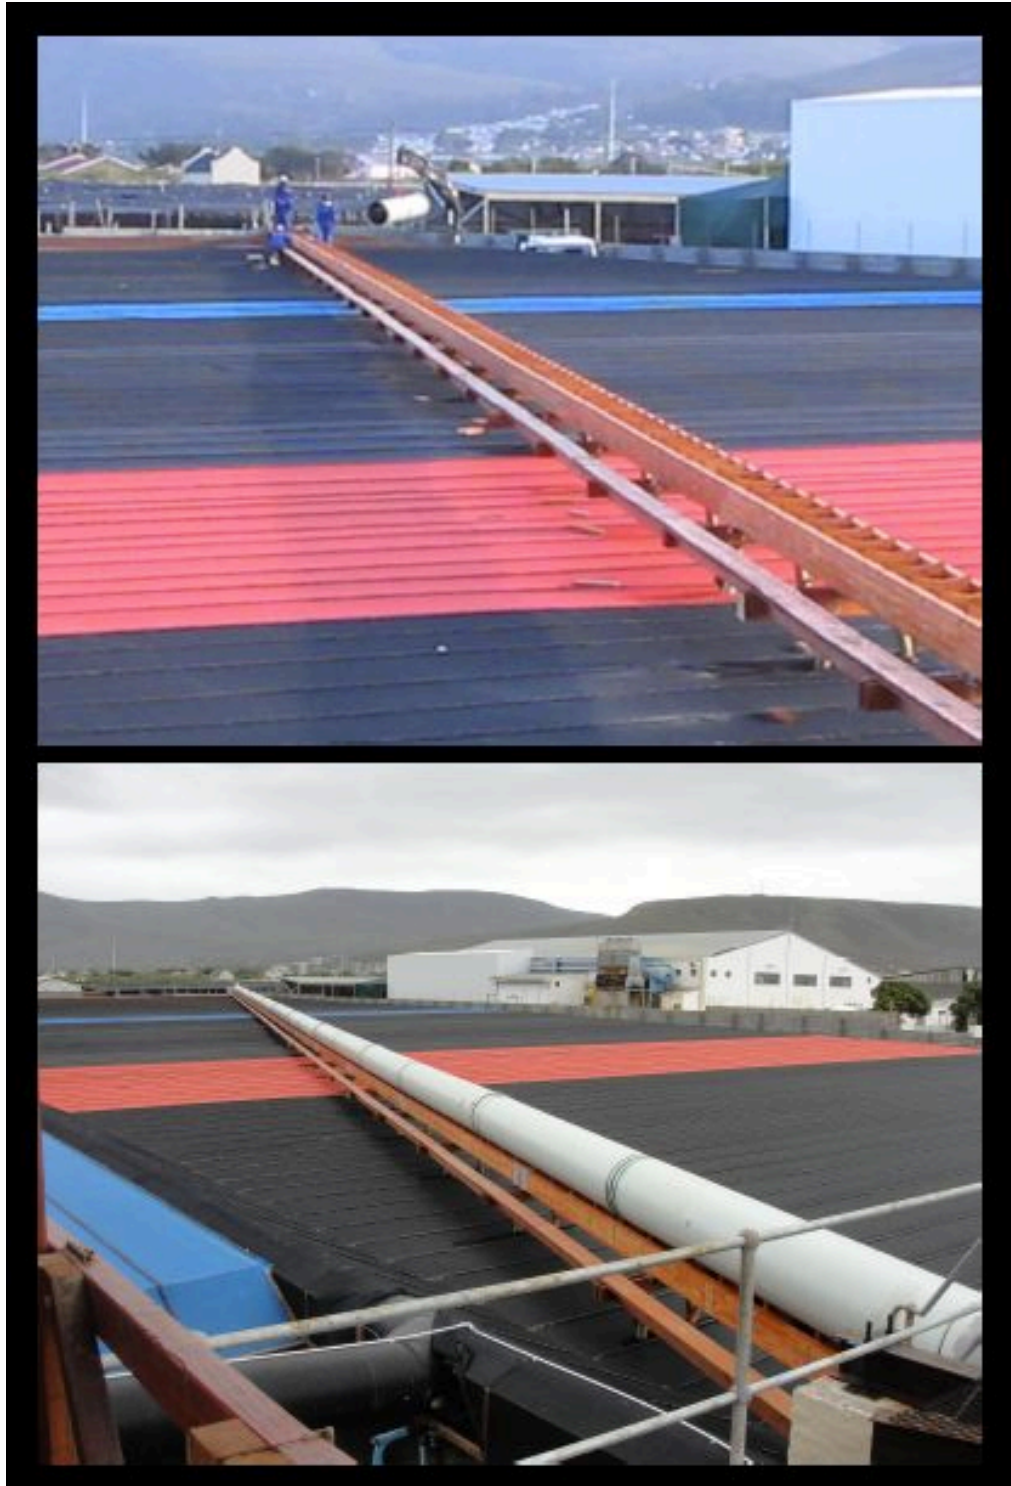
To secure the new pipeline across the top of Sea View farm, a support structure had to be built and each section of pipe was lifted onto the rails using a crane. The pipes were moved into position using a custom designed cart, inserted into the next section and then secured to the structure. This pipeline runs corner-to-corner across Sea View farm – a total of 150m in length.

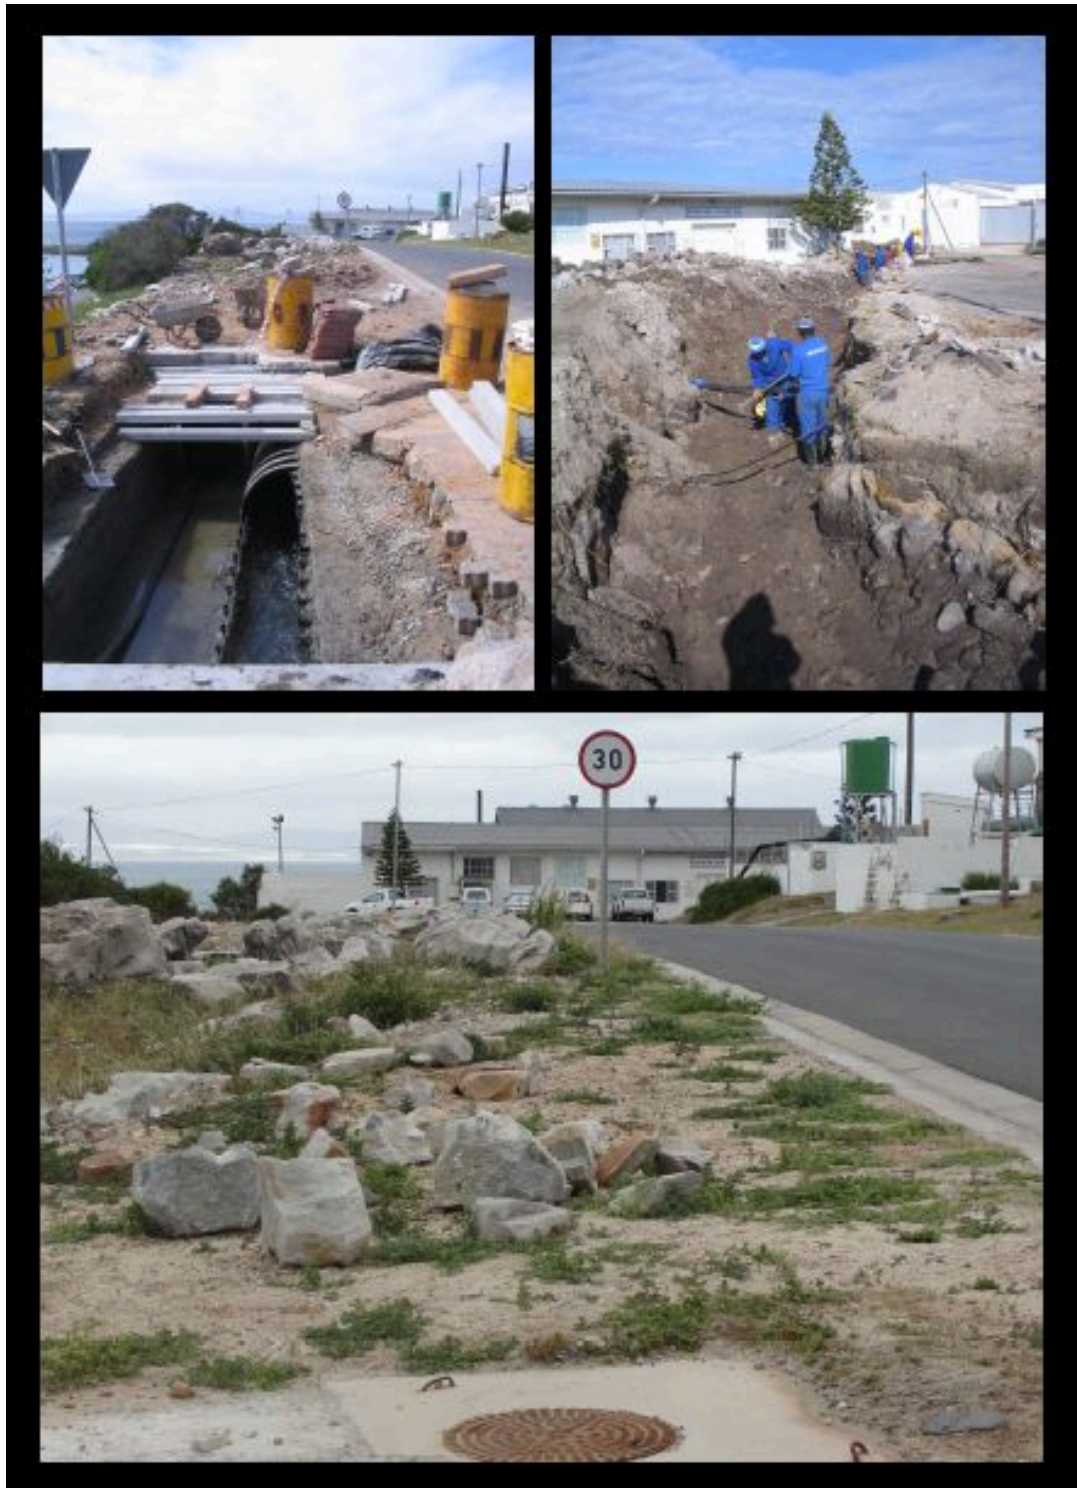
Bergsig effluent in New Harbour, Hermanus

In order to increase the effluent pipeline capacity from our Bergsig farm, a 200m long channel of 1.5m wide and 1.5 m deep had to be dug and in certain areas blasted through bedrock through the New Harbour. Additional pipes were installed to provide for the increased quantity of water passing through. Rehabilitation of areas where the work was done was of utmost importance to all involved. After the installation of the pipes, the area was cleaned and levelled, paving was repaired and vegetation re-established.
